Manhole Inspection Summary

Manhole # S51M__039MH

Location Address: **901 s potomac st**

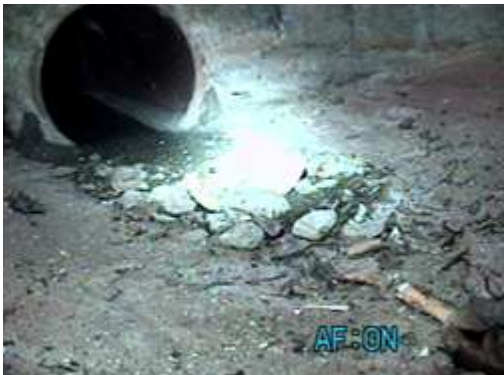
Misc

channel debris

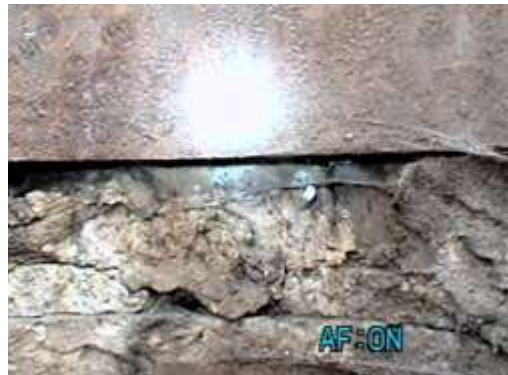
Defect 2

Condition: ☐ Sound ☐ Cracked ☐ Root Intrusion ☒ **Loose Brick** ☒ **Deteriorated**

chimney loose bricks and deteriorated, frame adj

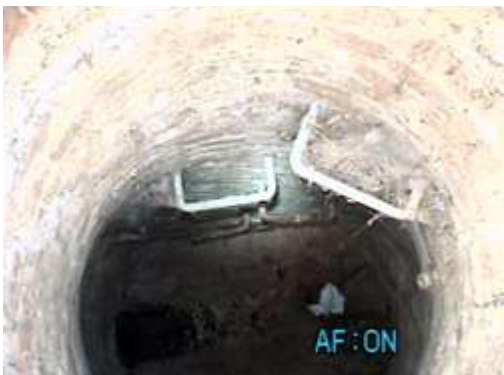
Defect 1

Count: **4** Missing: **0** ☒ **Corroded**

cor. steps
